Article

Monitoring of Composite Structures for Re-Usable Space Applications Using FBGs: The Influence of Low Earth Orbit Conditions

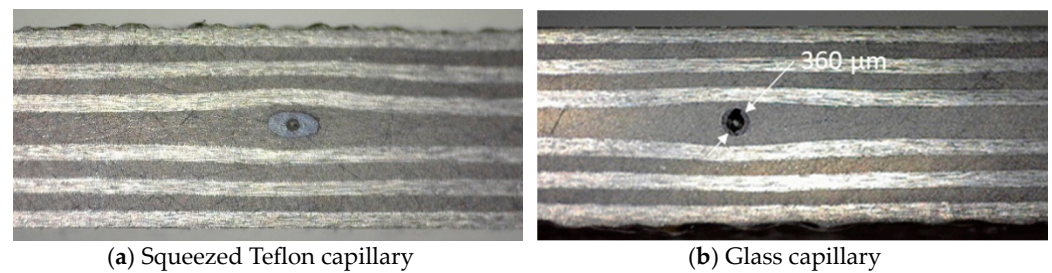
Figure 2. The cross-section of 2 coupons (lay-up $[0/90]_{3s}$) with embedded Teflon (a) or glass (b) capillary.

In this paper, the same method was used to realize strain-insensitive temperature sensors. Since Teflon tubing was found to be incompatible with the ATL process used to manufacture the coupons (the tubing was squeezed, as shown in Figure 2a), a glass capillary was used (which retained its form as shown in Figure 2b). An FBG-scan 808D interrogator (bandwidth: 1510–1590 nm, resolution 0.8 nm/pixel) from FBGS (Jena, Germany) was used to acquire the FBG reflection spectra and to perform the strain measurements. The used FBGs were off-the-shelf draw tower gratings (DTG), also obtained from FBGS, which have a length of 8 mm, can measure strains up to 5% and temperatures between -200 and $+200\text{ }^{\circ}\text{C}$, and have a typical strain sensitivity of $1.2\text{ pm}/\mu\epsilon$ and a temperature sensitivity of $10\text{ pm}/^{\circ}\text{C}$.

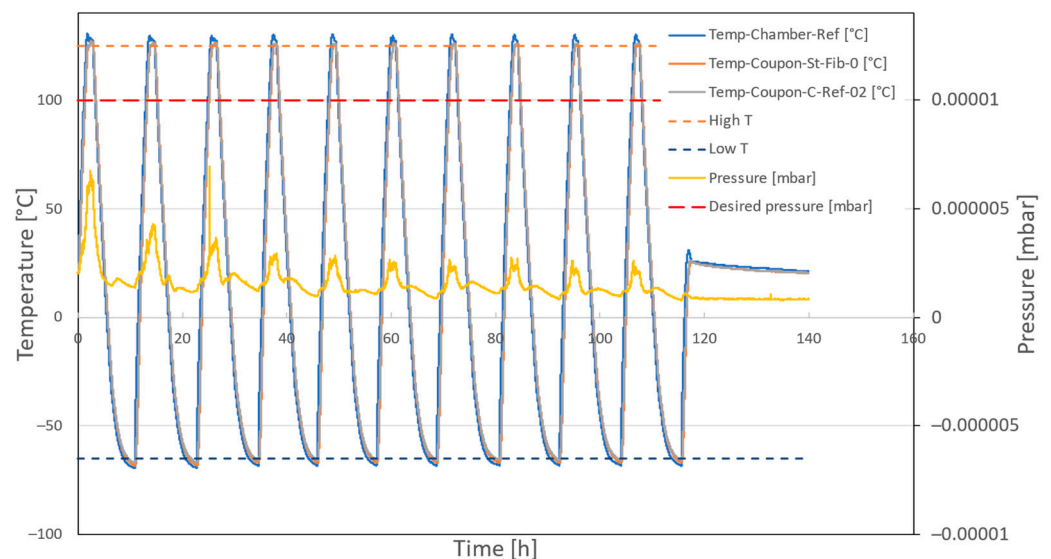
Figure 5. The measured temperature and pressure inside the autoclave during the TVac conditioning of the coupons. The dashed lines indicate the desired minimum and maximum temperature and maximum desired pressure. The yellow curve shows the measured pressure in the autoclave during TVac conditioning. The blue, orange, and grey curves show the temperature as measured with three thermocouples inside the autoclave. Two of these were taped to a coupon, and the third one was taped to the platform in the autoclave.

The coupons were placed in an autoclave where a vacuum was created with a maximum pressure of 10^{-5} mbar, and the temperature was varied between -65 °C and 125 °C for 10 cycles. The measured temperatures and pressure during the cycling are depicted in Figure 5. The temperature was measured with three thermocouples; two of these were taped to a coupon, and the third was taped to the platform in the autoclave.

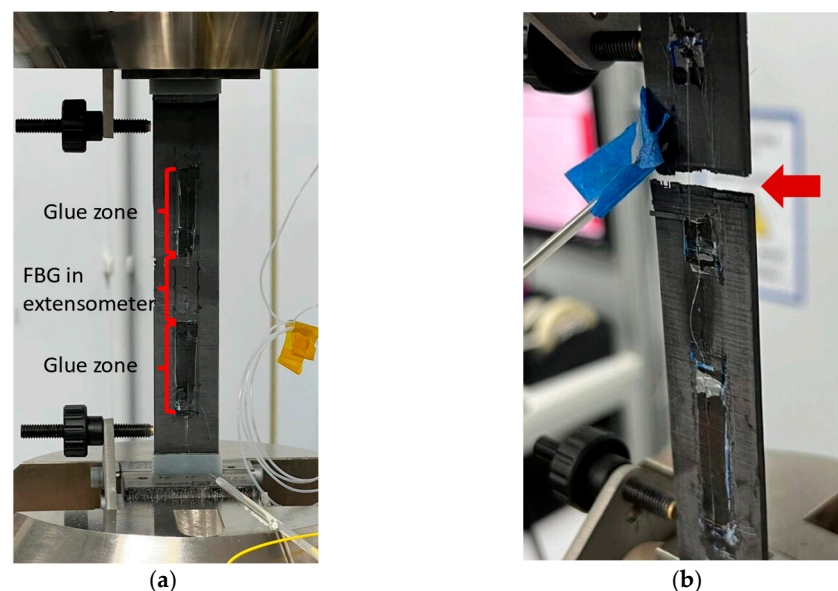
Figure 6. A tensile test coupon mounted in the test machine (a) before and (b) after the tensile testing. The FBG installed in extensometer principle after TVac conditioning can be seen. The optical fiber was glued to the surface of the coupon on both sides of the FBG sensor ((a), glue zone), leaving the FBG itself free. As such, two anchors were created, which strained the FBG sensor during the experiment. (b) shows the fracture after tensile testing.

Five coupons were made with embedded FBG sensors and five without. All coupons were subjected to TVac conditioning and were then equipped with tabs and a reference strain sensor (FBG used in the extensometer principle (see Figure 6a). Subsequently, the coupons were tested by applying a tensile load until a fracture occurred. The tensile load was applied in the 0° direction, along the direction of the embedded OFs (see Figure 4). Figure 6 shows an example of a coupon mounted on the test bench before and after testing. The measurements of the reference strain sensors were compared with the measurements of the embedded FBG to determine the proper functioning of the embedded FBG after TVac conditioning.

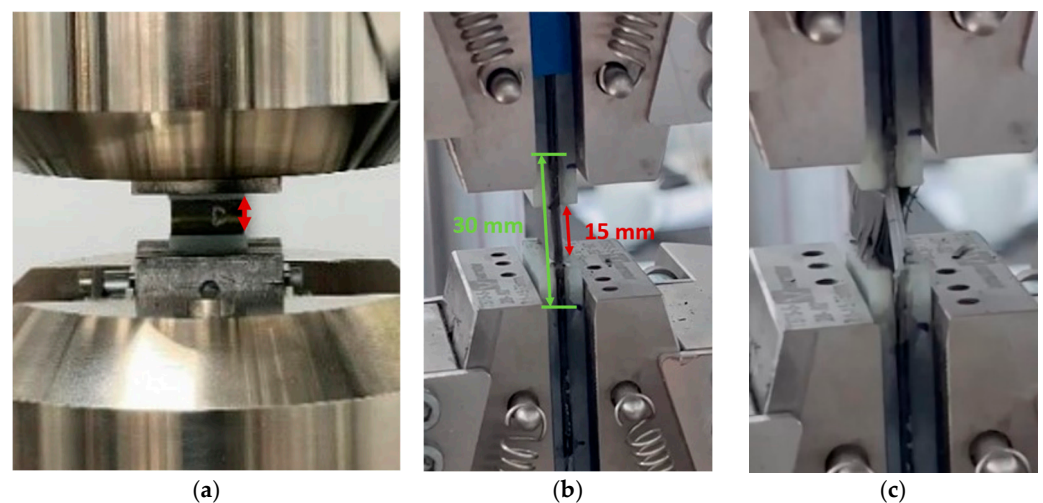
Figure 7. A coupon clamped in the test machine and a close-up before (a,b) and after (c) test. The green arrow in (b) shows the length over which the FBG is glued to the edge of the coupon. The FBG itself is located in the middle and is only 8 mm in length. The red arrows (a,b) show the free length of the coupon.

An example of a mounted coupon before and after testing is shown in Figure 7. The coupons were equipped with tabs, leaving 15 mm of free length (shown in red in Figure 7a,b). A reference strain sensor was applied by gluing an OF with FBG at the side of the coupon over a length of 30 mm (shown in green in Figure 7b). The coupons were clamped in and subsequently tested using a compressive load until fracture. The compression load was applied in the 0° direction, perpendicular to the direction of the embedded OF and capillary and perpendicular to the direction of the reinforcement fibers of the layers in which the OF and capillary were embedded. As such, this was the most critical case in terms of the loading direction versus the supporting reinforcement fibers' direction. For this reason, it was chosen to embed capillaries in the compression and ILSS (see Section 3.7) test coupons and not in the tensile test coupons.

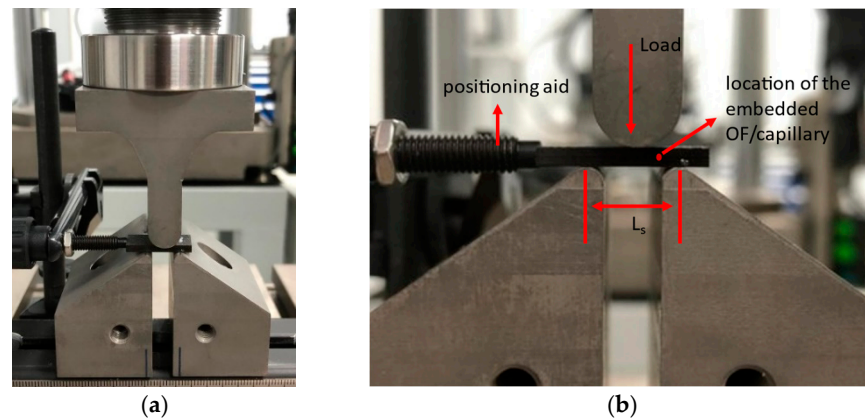
Figure 8. (a) Shows an ILSS test coupon mounted in the 3-point bending test setup. (b) shows a close-up of the mounted coupon. The support span L_s was 10 mm. The red dot indicates the position of the embedded OF or capillary, which was positioned in the middle between the support and loading point.

A coupon mounted on the three-point bending is shown in Figure 8. Figure 8a shows an overview, while Figure 8b shows a close-up of the mounted coupon. The loading span (L_s) was 10 mm and the coupon was positioned so that the embedded OF or capillary was located halfway between the loading point and support. The test was performed until delamination occurred.

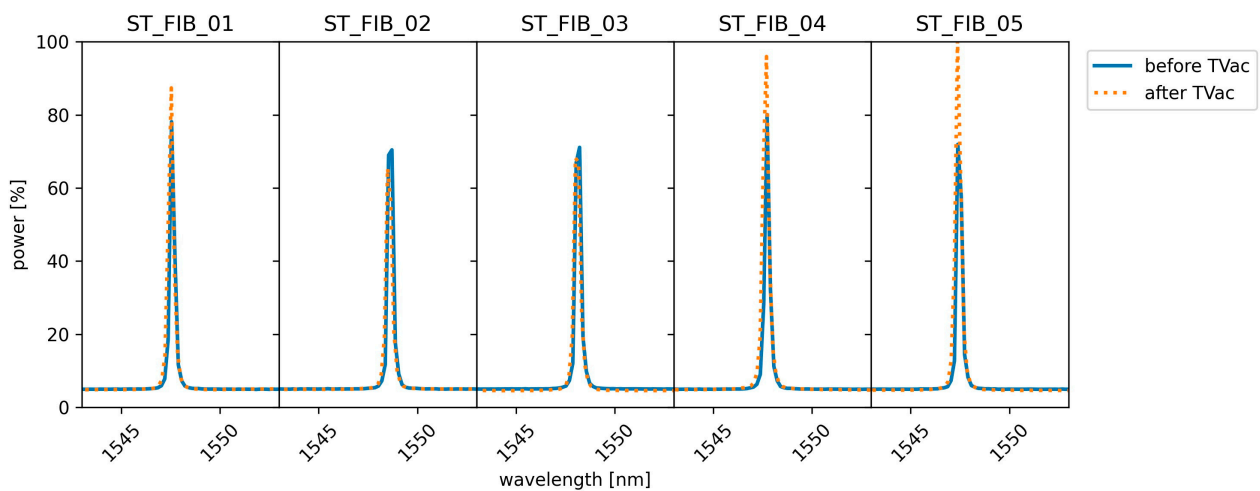
Figure 9. Comparison of the reflection spectra of the embedded FBGs in the 5 tensile test coupons taken before and after TVac conditioning at room temperature. No degradation of the spectra was observed.

To check the functionality of the FBGs embedded in the tensile test coupons before and after TVac conditioning, the reflection spectra were taken before and after TVac conditioning at room temperature, the results of which are shown in Figure 9 (per coupon). No peak distortion or significant reduction in reflection could be seen in the spectra after 10 cycles of TVac conditioning, meaning that peak tracking (needed for strain measurements) remained possible, ensuring the sensor's functionality. This is in correspondence with the results found in [22] on the temperature sensors on the PROBA-II mission and in [25], where LEO conditions were simulated by TVac cycling in combination with UV radiation and an atomic oxygen environment.

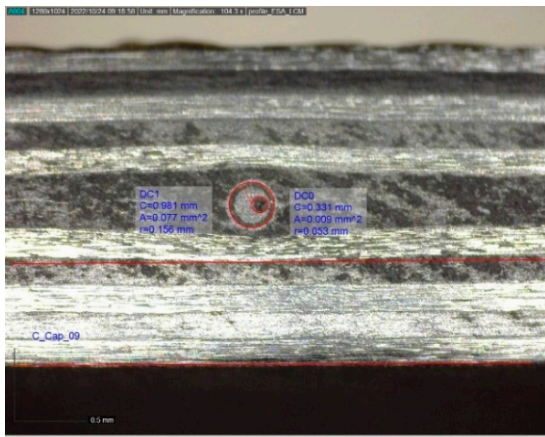
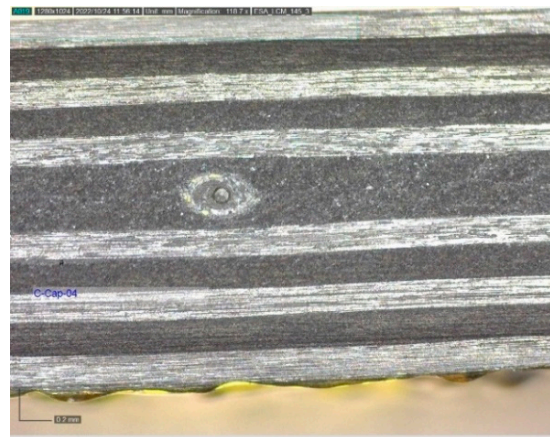
(a) Non-TVac-conditioned coupon

(b) TVac-conditioned coupon

Figure 10. Example of 2 polished compression test coupons with an integrated 250/360 μm capillary.

Figures 10–13 show examples of polished coupons with embedded 250/360 μm and 106/160 μm inner/outer diameter capillaries, embedded OFs, and coupons without embedded structures. In these figures, (a) shows the polished cross-section of a coupon that was not TVac conditioned and (b) shows another coupon that was TVac conditioned. No delamination or degradation due to TVac cycling could be seen. The same result was found for all the coupons (Appendix A). A comparable result was found in [8], where it was mentioned that no delamination was found in coupons with embedded OFs after 5 thermal cycles ($-170\text{ }^{\circ}\text{C}$ – $+135\text{ }^{\circ}\text{C}$ in an N_2 environment).

The breakage of the capillary, as shown in Figure 10b, seems to originate from the manufacturing process, which is proven by the presence of resin within the capillary (lighter color in the image; otherwise, this should have been black like in Figure 11). In the following experiments, this has been avoided by placing the capillary in between two ATL prepreg tapes, leading to a better accommodation of the capillary within the CFRP.

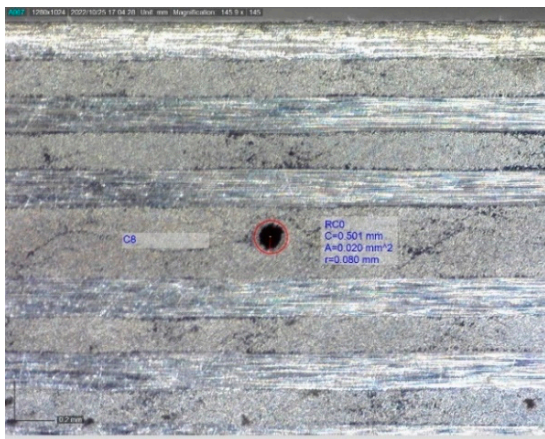
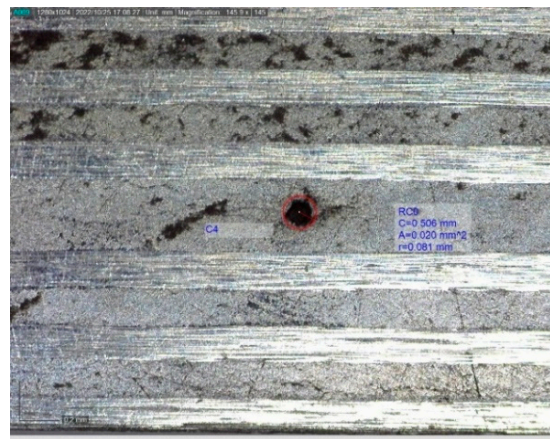
(a) Non-TVac-conditioned coupon

(b) TVac-conditioned coupon

Figure 11. Example of 2 polished samples from the ILSS test coupons with an integrated 106/160 μm capillary.

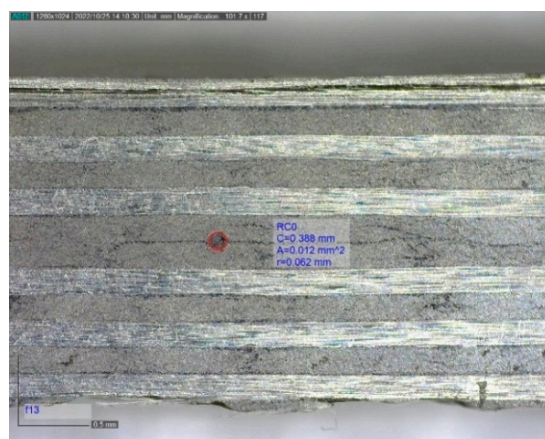
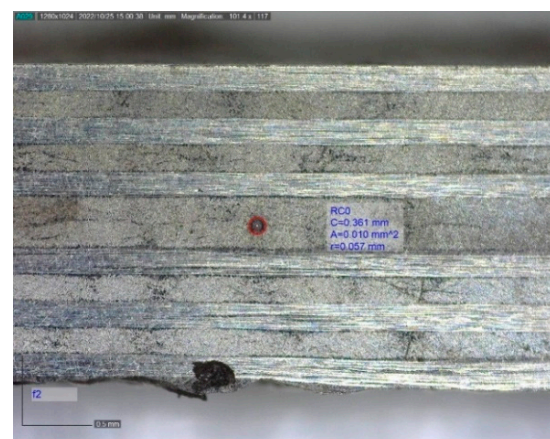
(a) Non-TVac-conditioned coupon

(b) TVac-conditioned coupon

Figure 12. Example of 2 polished samples from the ILSS test coupons with an integrated 80/120 μm OF.

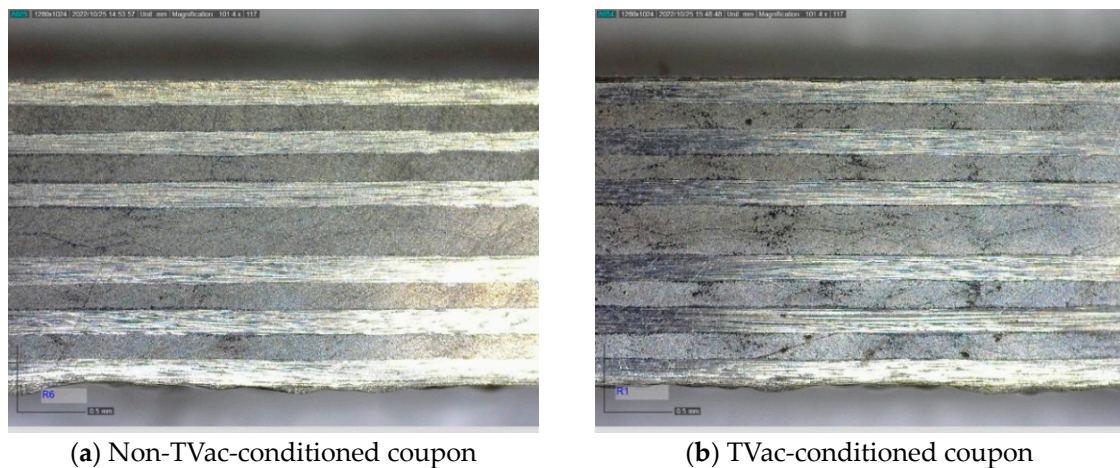
Figure 13. Example of 2 polished samples from the ILSS test coupons without an embedded OF or capillary.

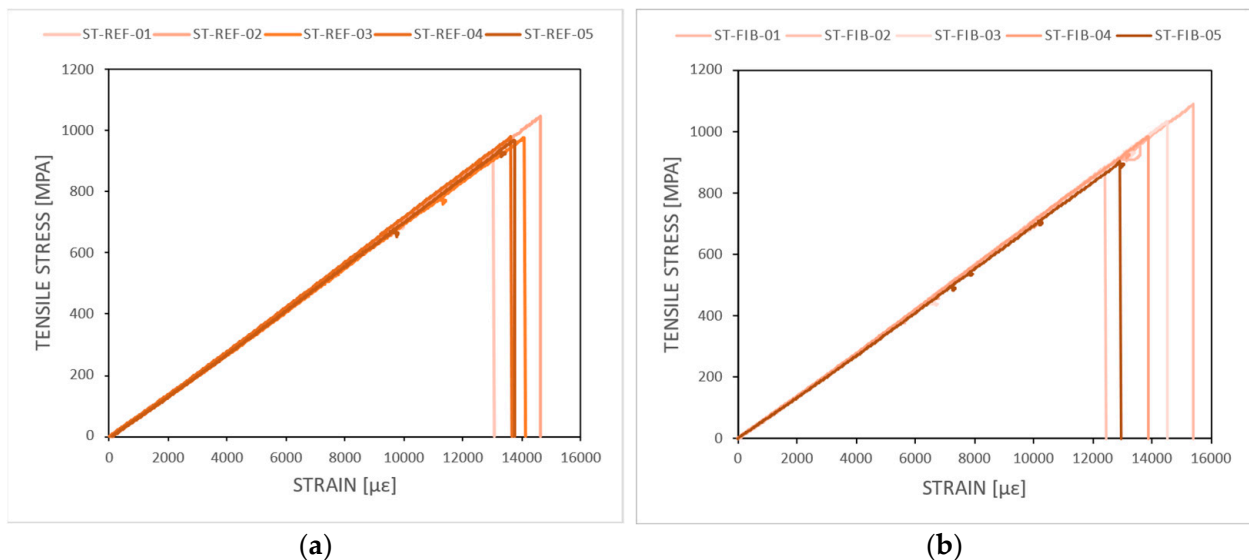
Figure 14. The stress–strain curve as a result of the tensile test obtained by combining the load data from the test bench with the strain measurements from the FBGs applied in extensometer principle. (a) Shows the results for the reference coupons (“ST-REF”, no embedded OF or capillary). (b) Shows the results for coupons with embedded OF (“ST-FIB”).

Figure 14 shows the stress–strain curves resulting from the quasi-static tension test for all 10 coupons (5 with embedded OF with FBG and 5 without) that were tested after being TVac conditioned. A bar chart summarizing the tensile failure strength and the tensile strain at failure (incl. standard deviations) is depicted in Figure 15, while a detailed overview of all individual test results is given in Appendix B.1.

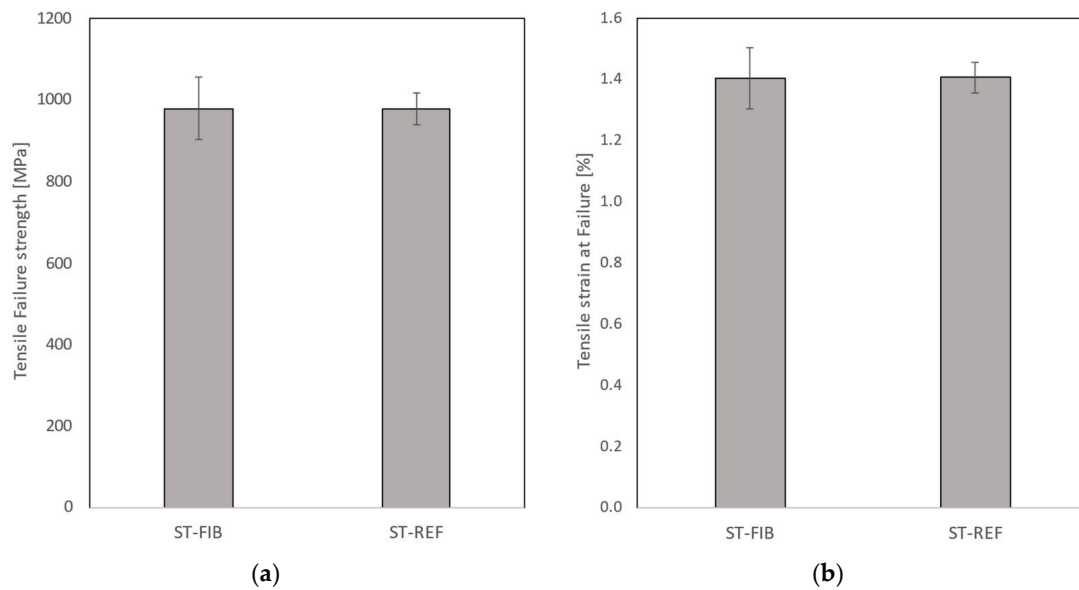
Figure 15. (a) The tensile failure strength and (b) tensile strain at failure obtained from the quasi-static tension testing. Coupons with (“ST-FIB”) and without (“ST-REF”) embedded OF after TVac conditioning were compared.

No difference in tensile strength (Figure 15) is observed between both types, although a slightly higher standard deviation is seen for the coupons with embedded OF, caused by one coupon (ST-FIB-02) that exhibited a lower tensile strength value. Comparable tests have been performed on unconditioned coupons in [23,27,29]. Various lay-ups were tested with embedded OFs parallel to the reinforcement fibers and no reduction in tensile strength was found compared to coupons without embedded OFs when the amount of embedded OFs is limited [29]. In [31], the influence of the angle of the embedded OF with respect to the interface of the layers in which it was embedded was tested. A reduction in tensile strength was found only when the OF was embedded in the 90° direction in a 0/45 interface.

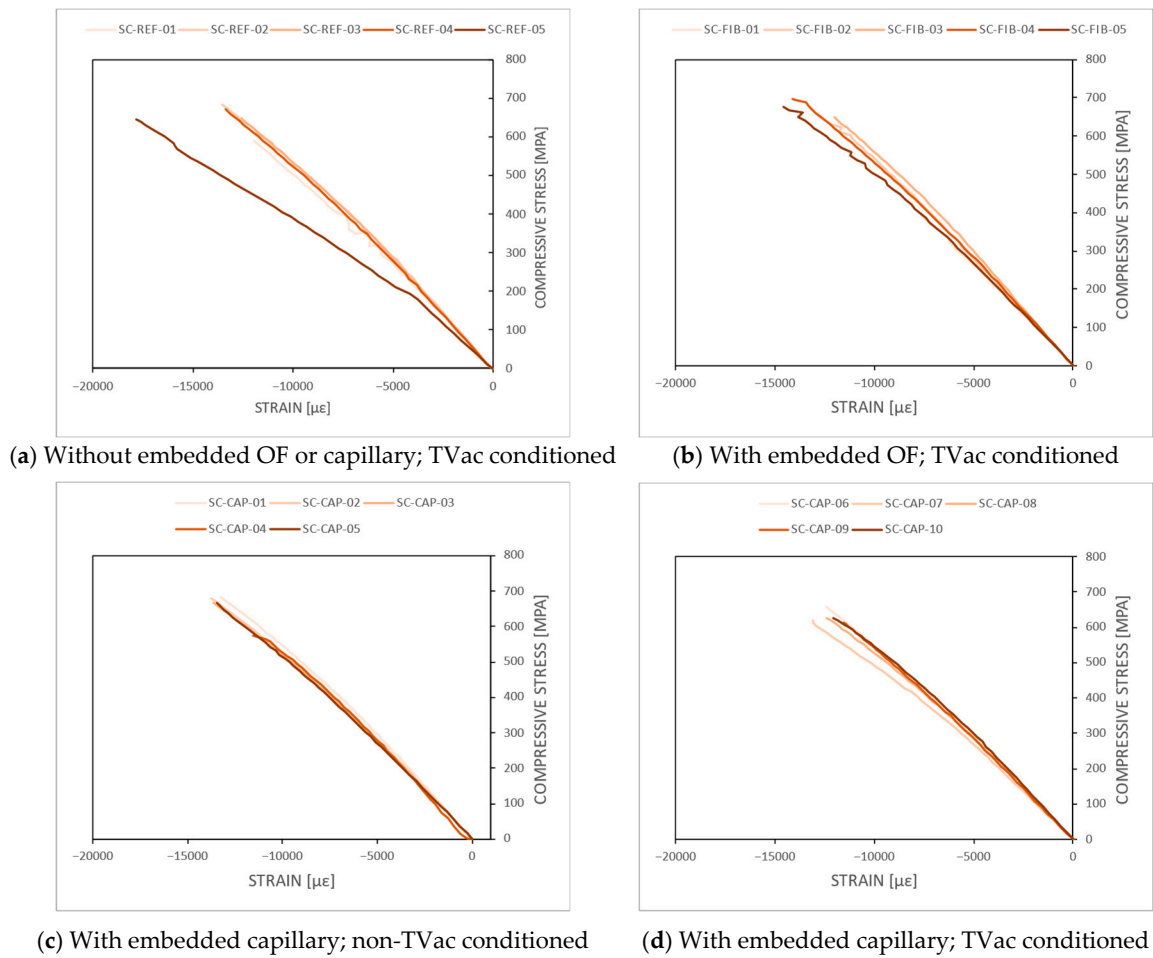
Figure 16. The stress–strain curves resulting from the quasi-static compression tests for the compressive test coupons. The stress was measured by the load cell, and the strain was obtained with the FBG sensors.

As the free length of the coupons clamped in on the test bench is shorter than the gluing length of the reference FBG glued on the side, the strain measured in this test is not reliable to determine the absolute strain at failure, as incomplete strain transfer from the coupon to the FBG could occur. However, these measurements can still be utilized to compare the different coupon types (REF, FIB, and CAP). The results indicate that, although small changes were observed between the different types of coupons, no significant effect related to the TVac conditioning could be discerned.

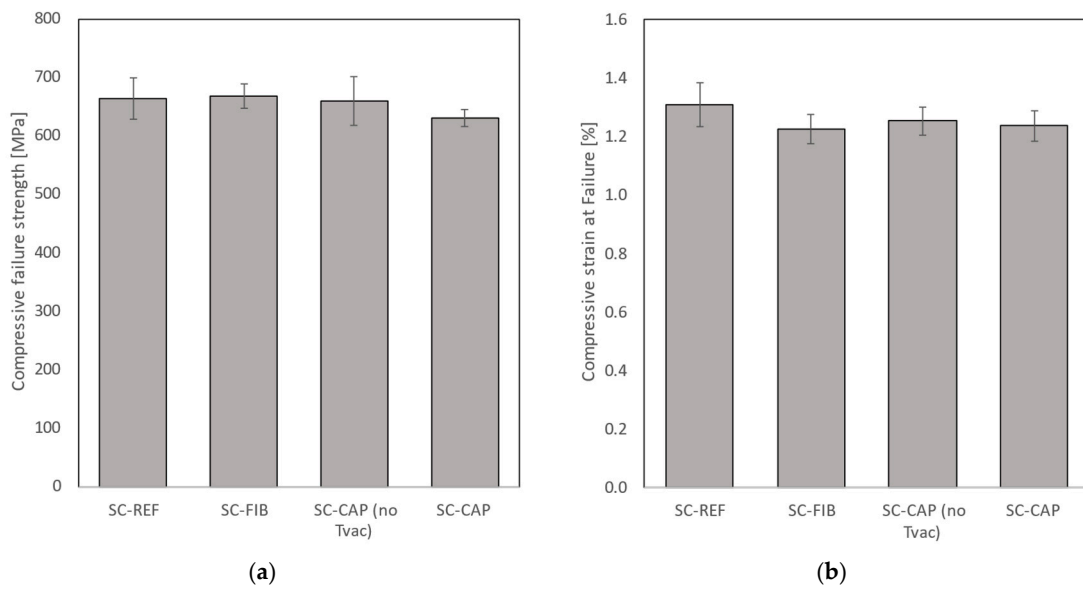
Figure 17. (a) Compressive failure strength and (b) compressive strain at failure obtained from quasi-static compression testing. TVac-conditioned coupons without embedded structures and with embedded OFs and capillaries are compared as well as coupons with embedded capillaries but which were not TVac conditioned.

No significant difference in compressive strength was observed among the different coupon types. The mean compressive strength of the TVac-conditioned coupons with embedded capillaries was 631.24 ± 16.22 MPa, which is slightly lower compared to the mean compressive strength value of their unconditioned counterparts, 660.46 ± 46.57 MPa. However, this difference falls within the standard deviation of the latter, indicating no significant variation in compressive strength between unconditioned and conditioned coupons.

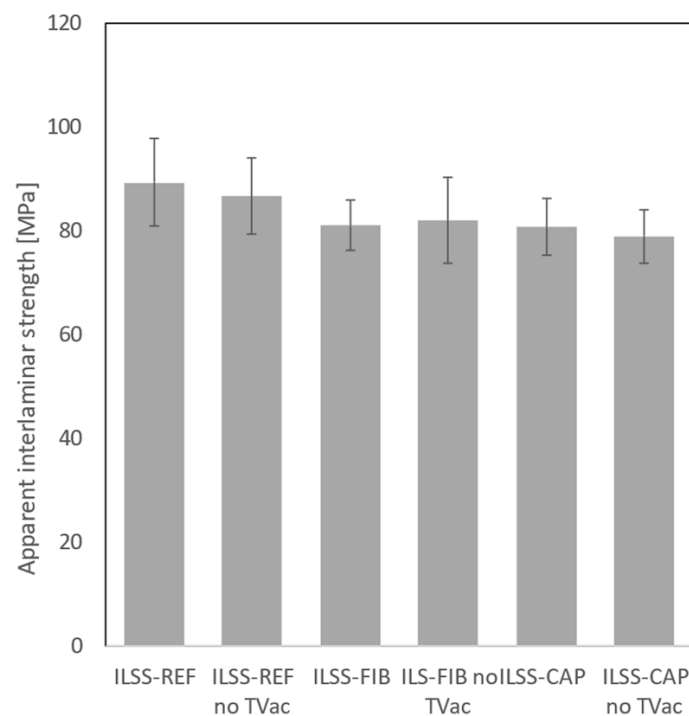
Figure 18. Bar chart of the apparent interlaminar shear strength for the different types of coupons.

Figure 18 shows the mean apparent interlaminar strength of the coupons. An overview of all results is given in Appendix B.3.

A slight decrease in interlaminar shear strength of about 8% was observed for the coupons with embedded OF (“FIB”) or capillary (“CAP”) compared to the reference coupons (“REF”). Given the small size of the coupons, it was expected that the effect of embedding a non-carbon fiber or capillary would be more pronounced due to a decrease in the volume fraction of the carbon reinforcement fiber. Previous research [32,33] reported similar results for tests conducted on unconditioned coupons. It was concluded that the influence of embedded optical fibers is minimal, if not negligible, given some specific restrictions. These restrictions can in principle be summarised as follows: the OF must be embedded between two layers parallel to the reinforcement fibers, and the volume fraction of the embedded OF needs to be low.

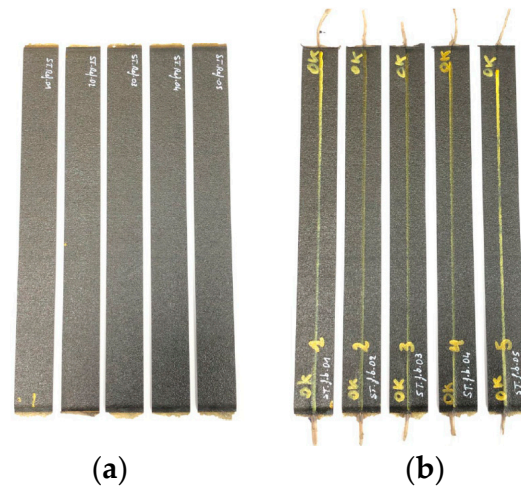
Figure A1. Tensile test coupons overview. (a) Reference coupons without embedded OF/capillary. (b) Coupons with 80/120 μm fiber embedded along the yellow line.

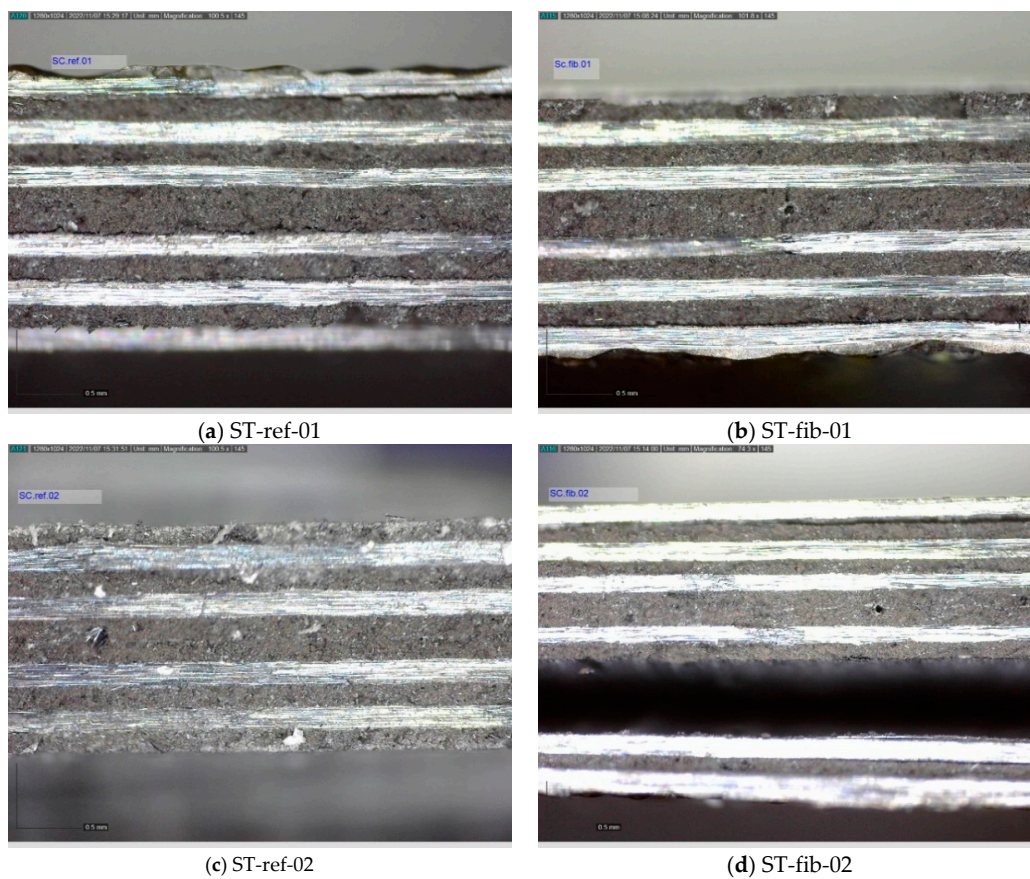
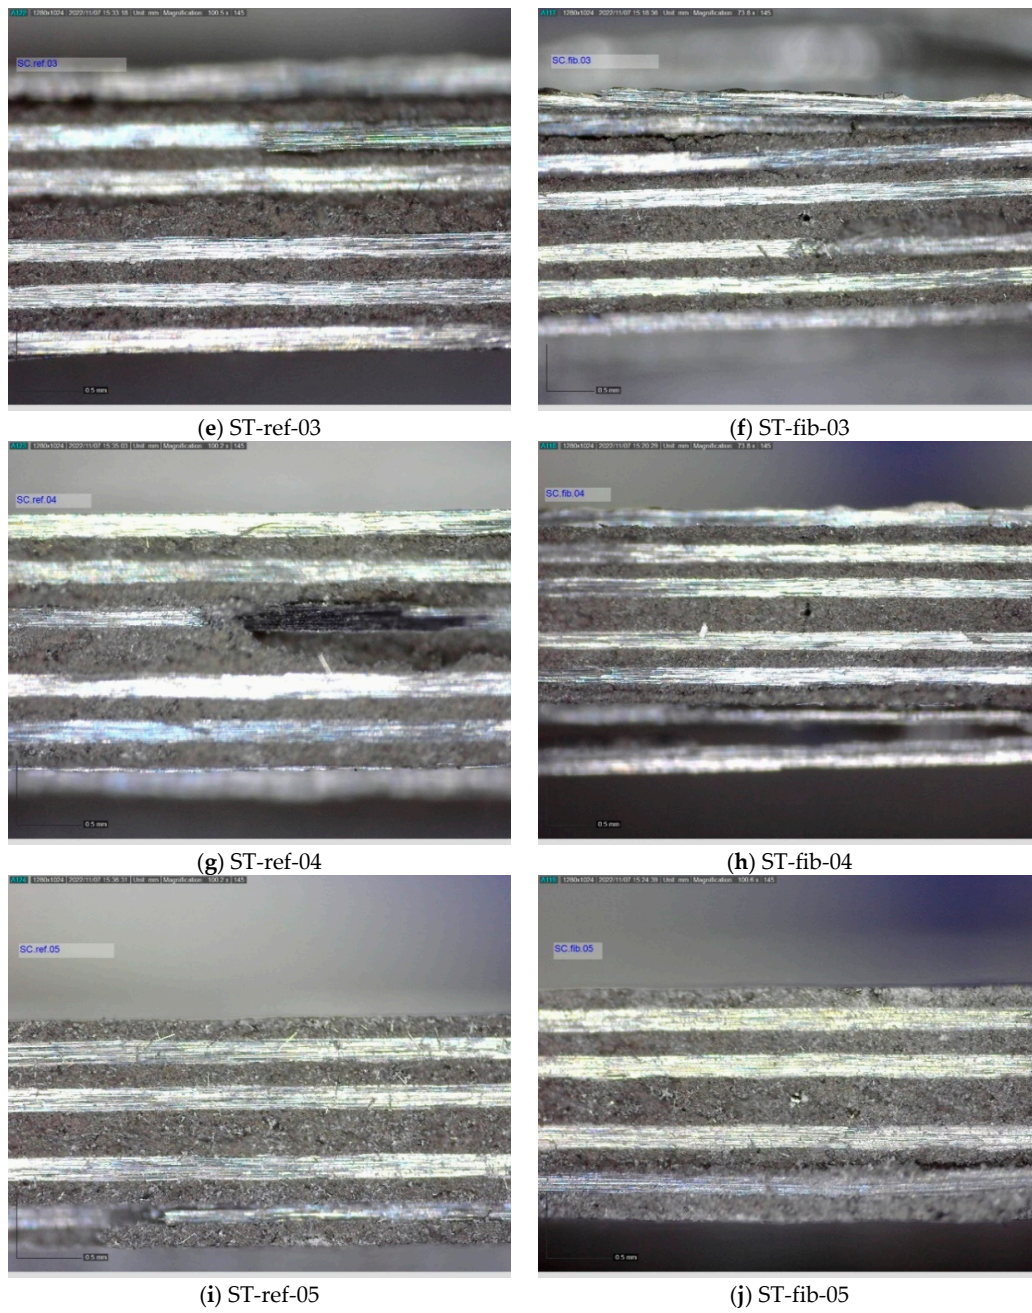
Figure A2. Cross-sections of the tensile test coupons taken after TVac conditioning.
Appendix A.2. Compression Test Coupons

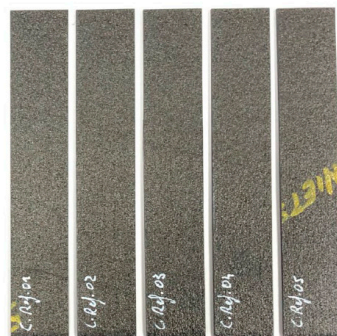
Figure A3. Compression test reference coupons without embedded OF/capillary.

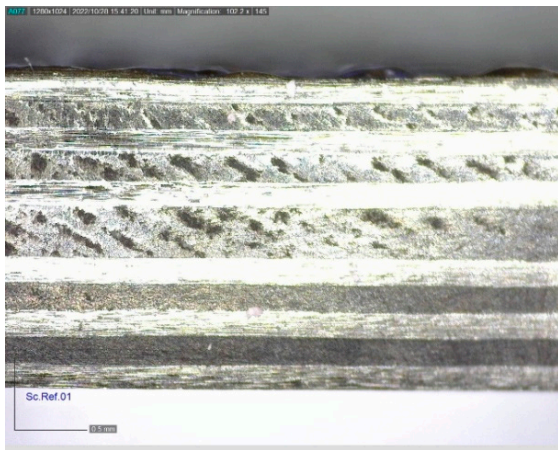
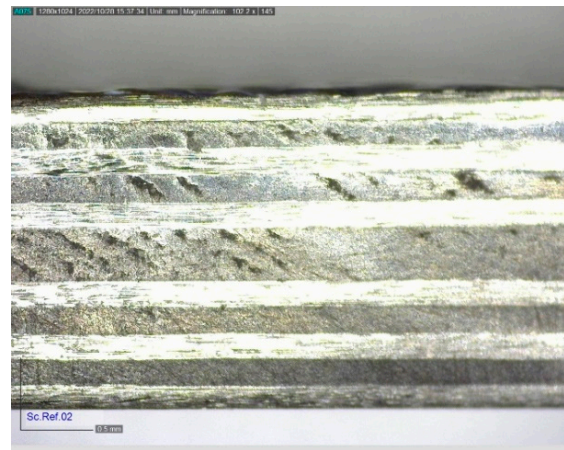
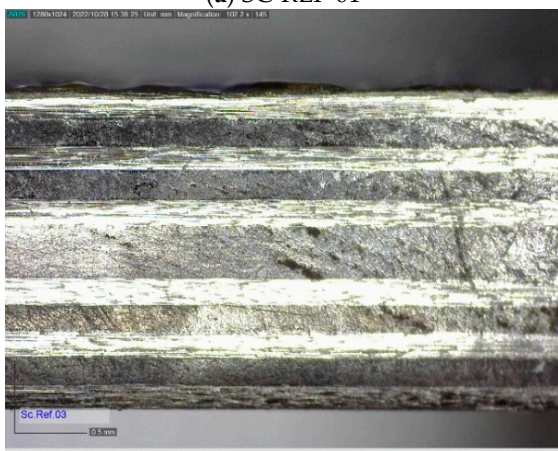
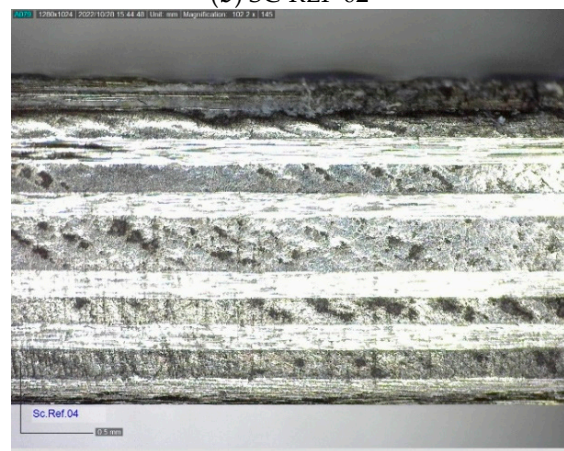
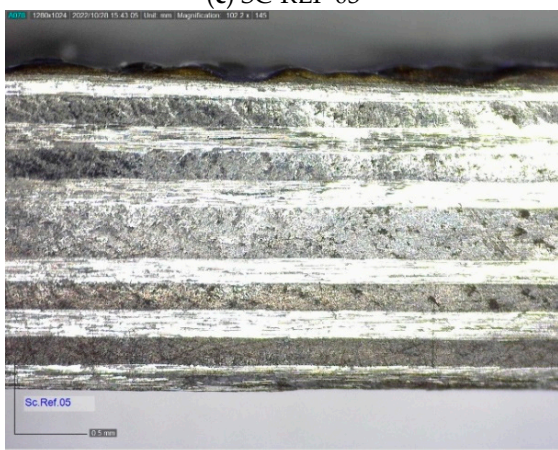
Figure A4. Cross-sections of the compression test reference coupons without embedded OFS/capillary taken after TVac conditioning.

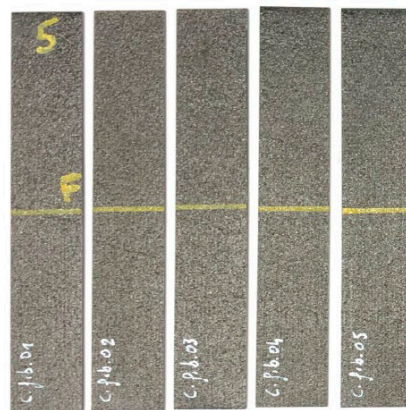
Figure A5. Compression test coupons with 80/120 μm fiber embedded along the yellow line.

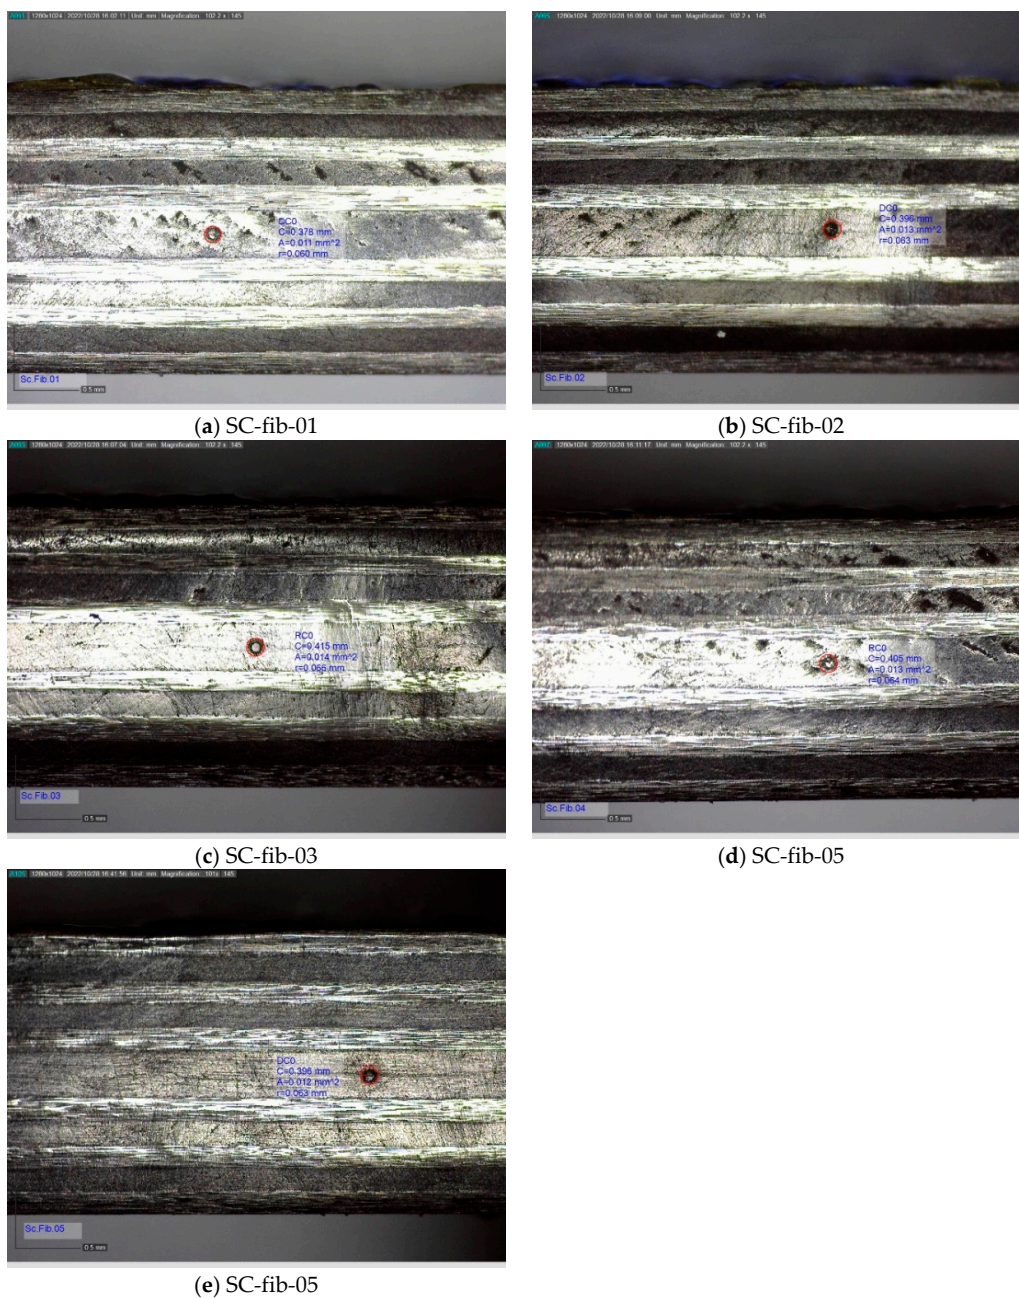
Figure A6. Cross-sections of the compression test coupons with embedded OF taken after TVac conditioning.

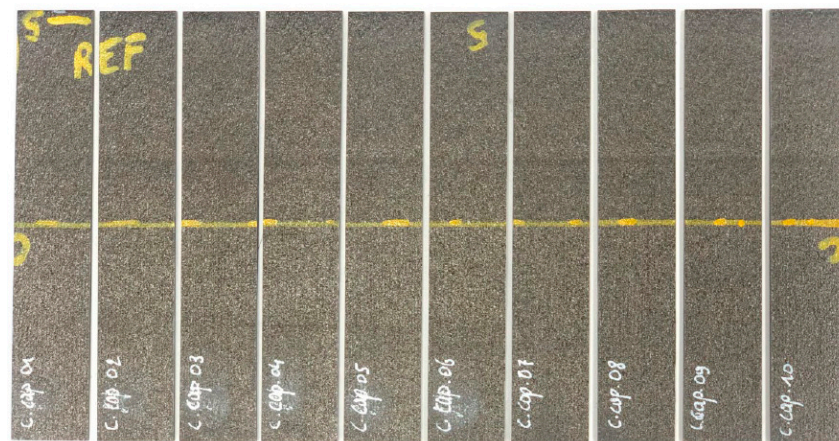
Figure A7. Compression test coupons with 250/360 μm capillary embedded along the yellow line.

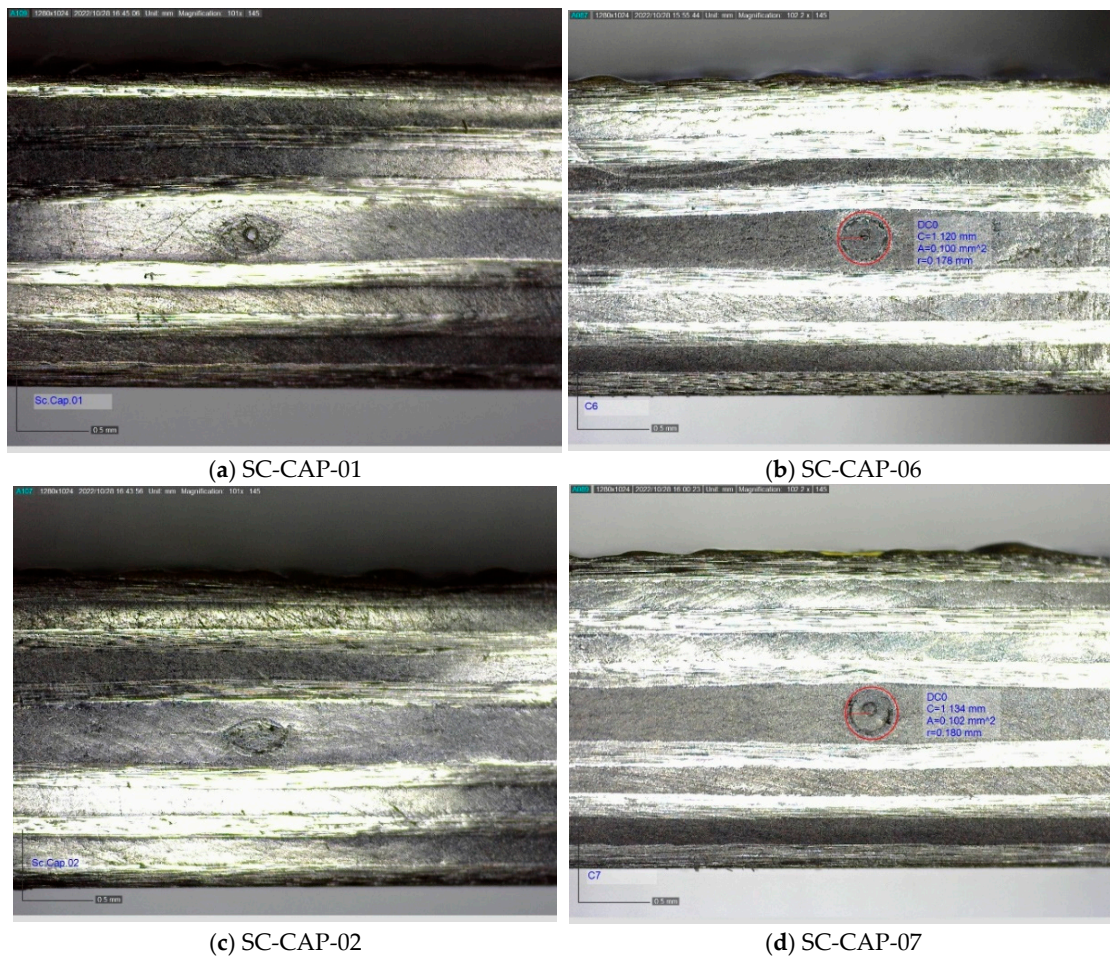
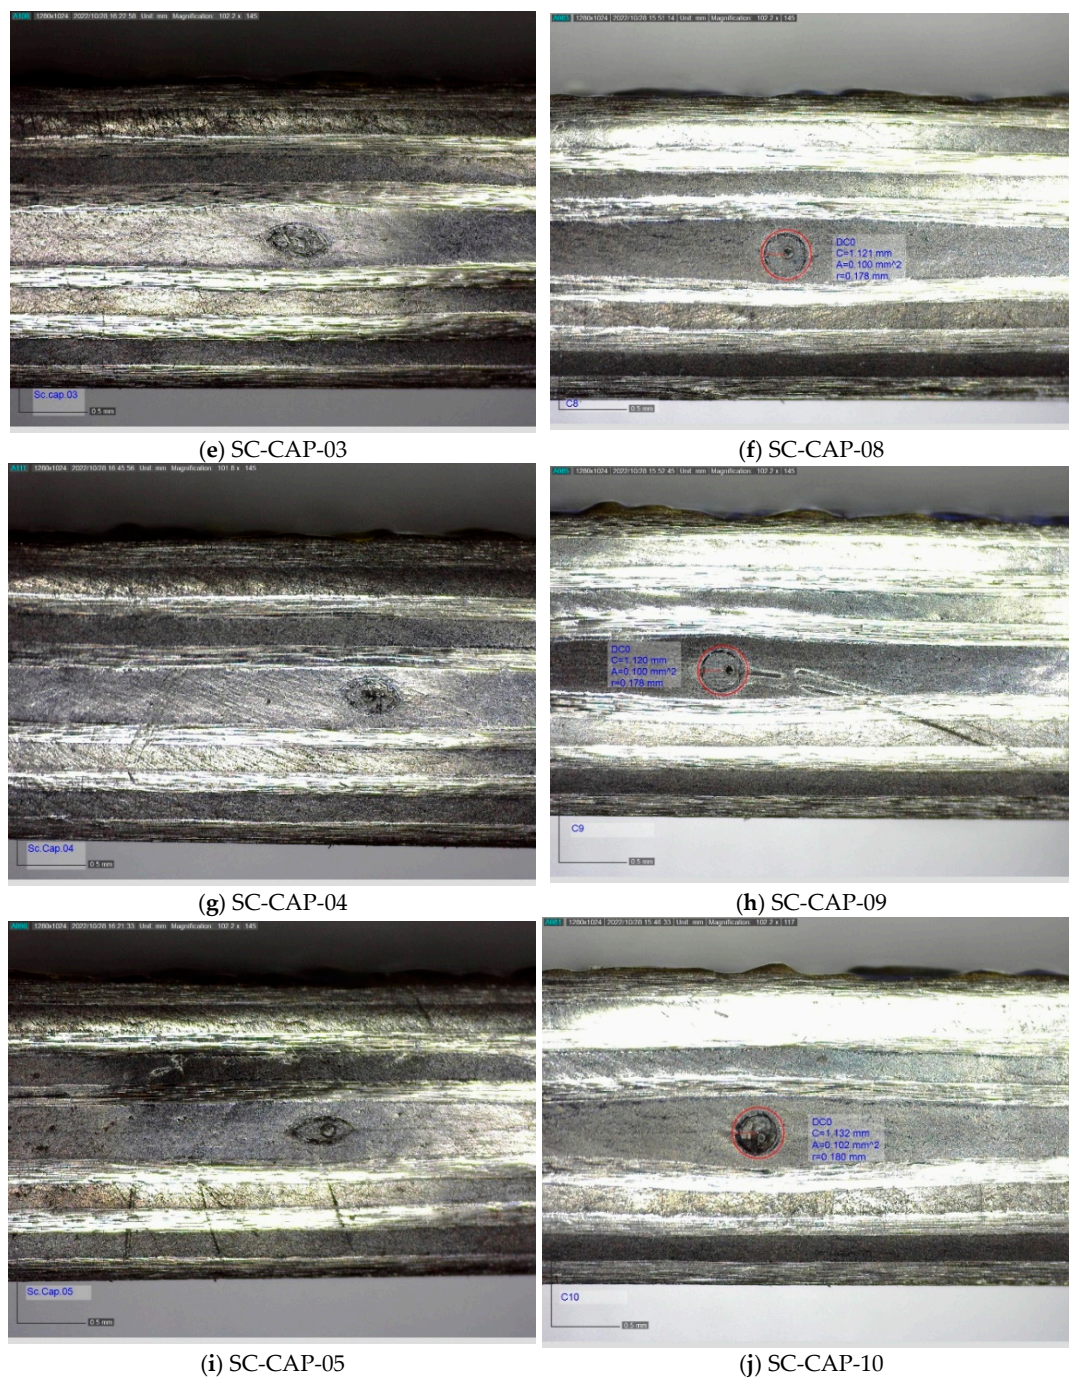
Figure A8. Cross-sections of the compression test coupons with embedded capillary. The figures on the (left (a,c,e,g,i)) are from the coupons that were not TVac conditioned. The figures on the (right (b,d,f,h,j)) are taken after TVac conditioning.

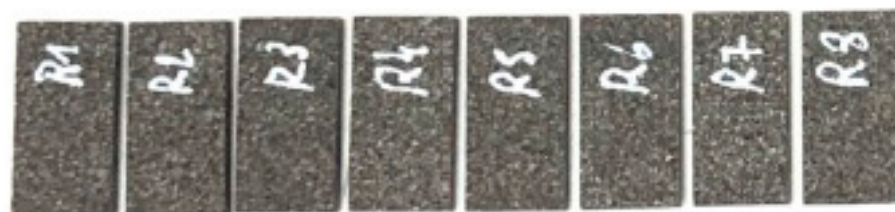
Figure A9. ILSS reference coupons without embedded OF/capillary.

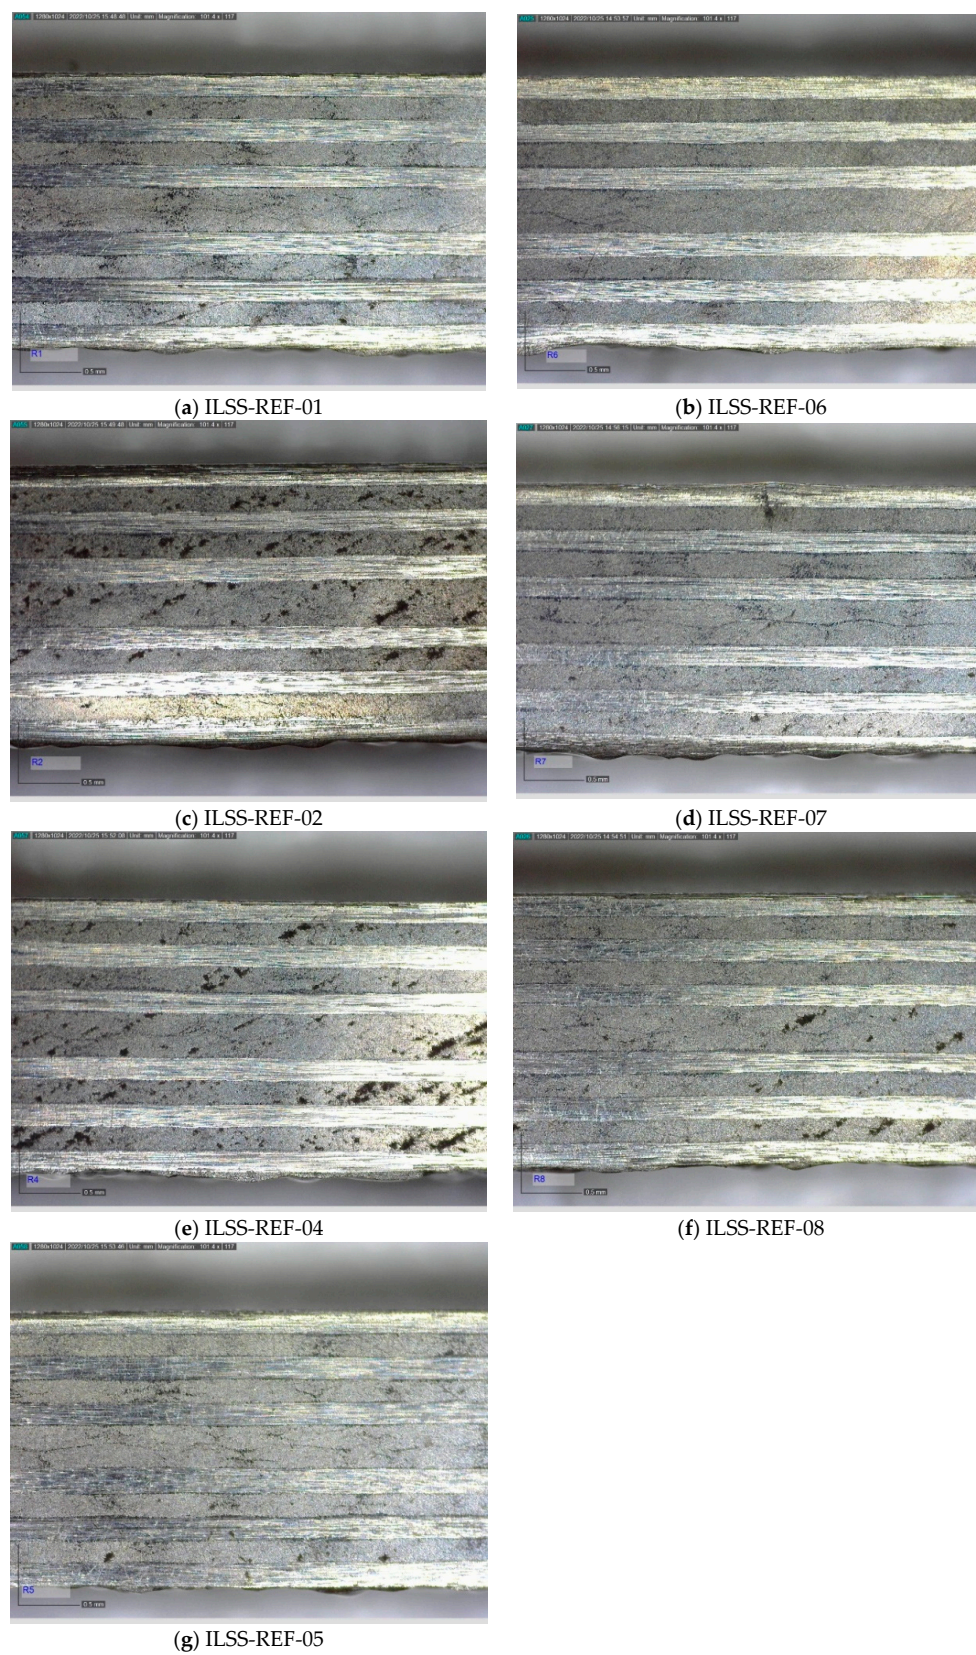
Figure A10. Cross-sections of the ILSS test reference coupons without embedded OF/capillary. The figures on the **(left (a,c,e,g))** are from coupons after TVac conditioning. The figures on the **(right (b,d,f))** are from coupons that were not TVac conditioned. Note that the cross-section of ILSS-REF-03 is missing.
