Article

Monitoring of Composite Structures for Re-Usable Space Applications Using FBGs: The Influence of Low Earth Orbit Conditions

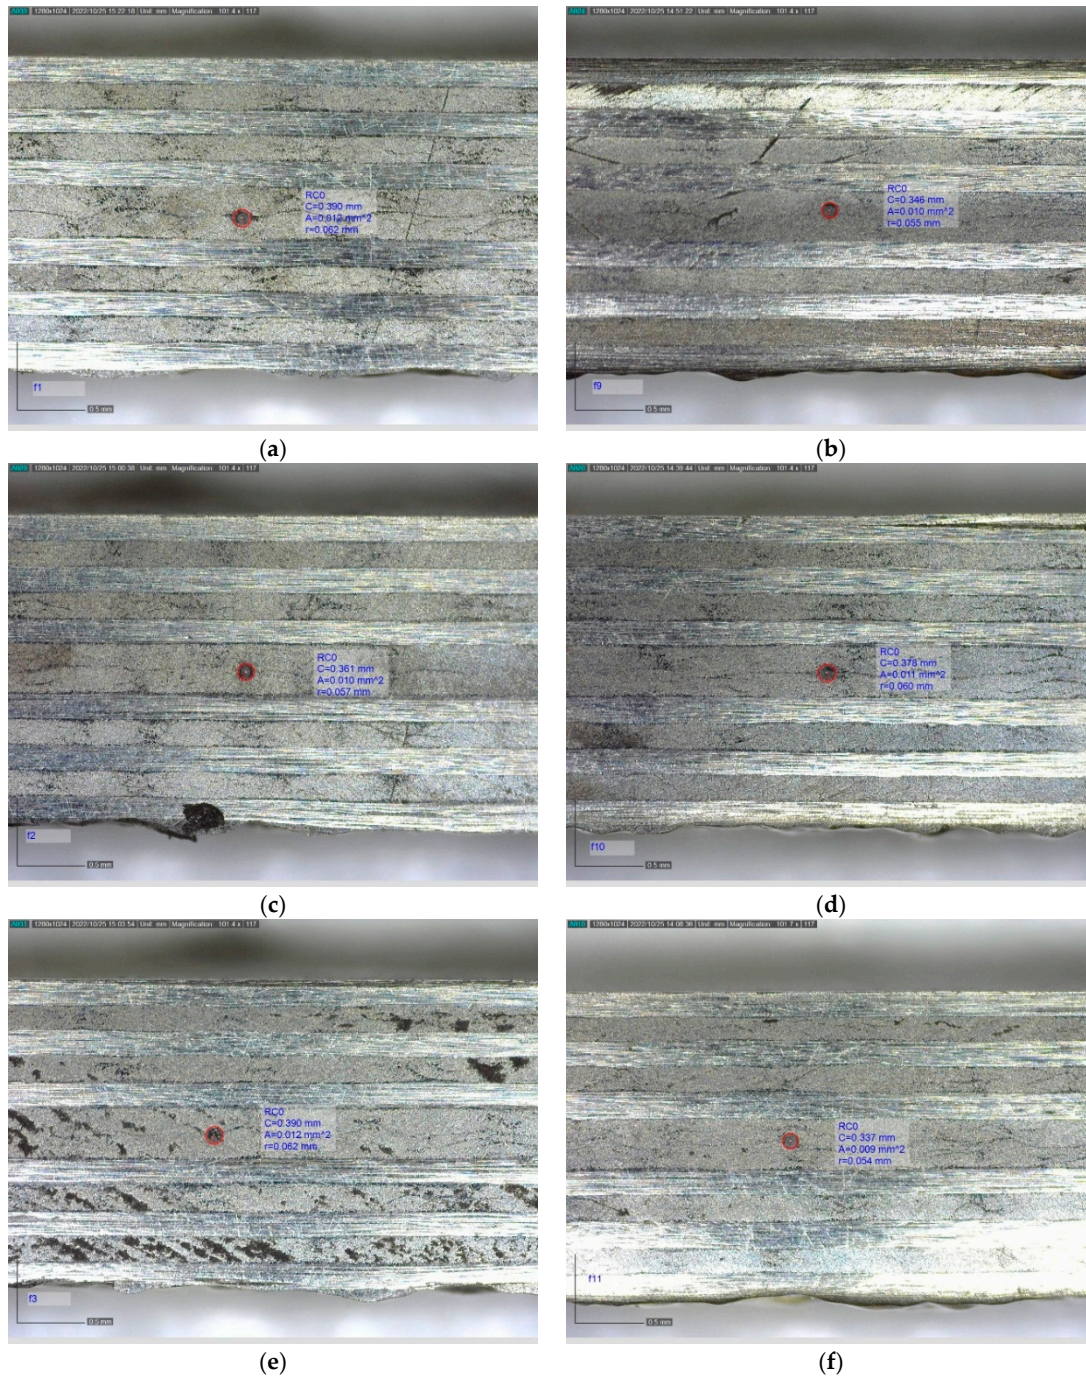
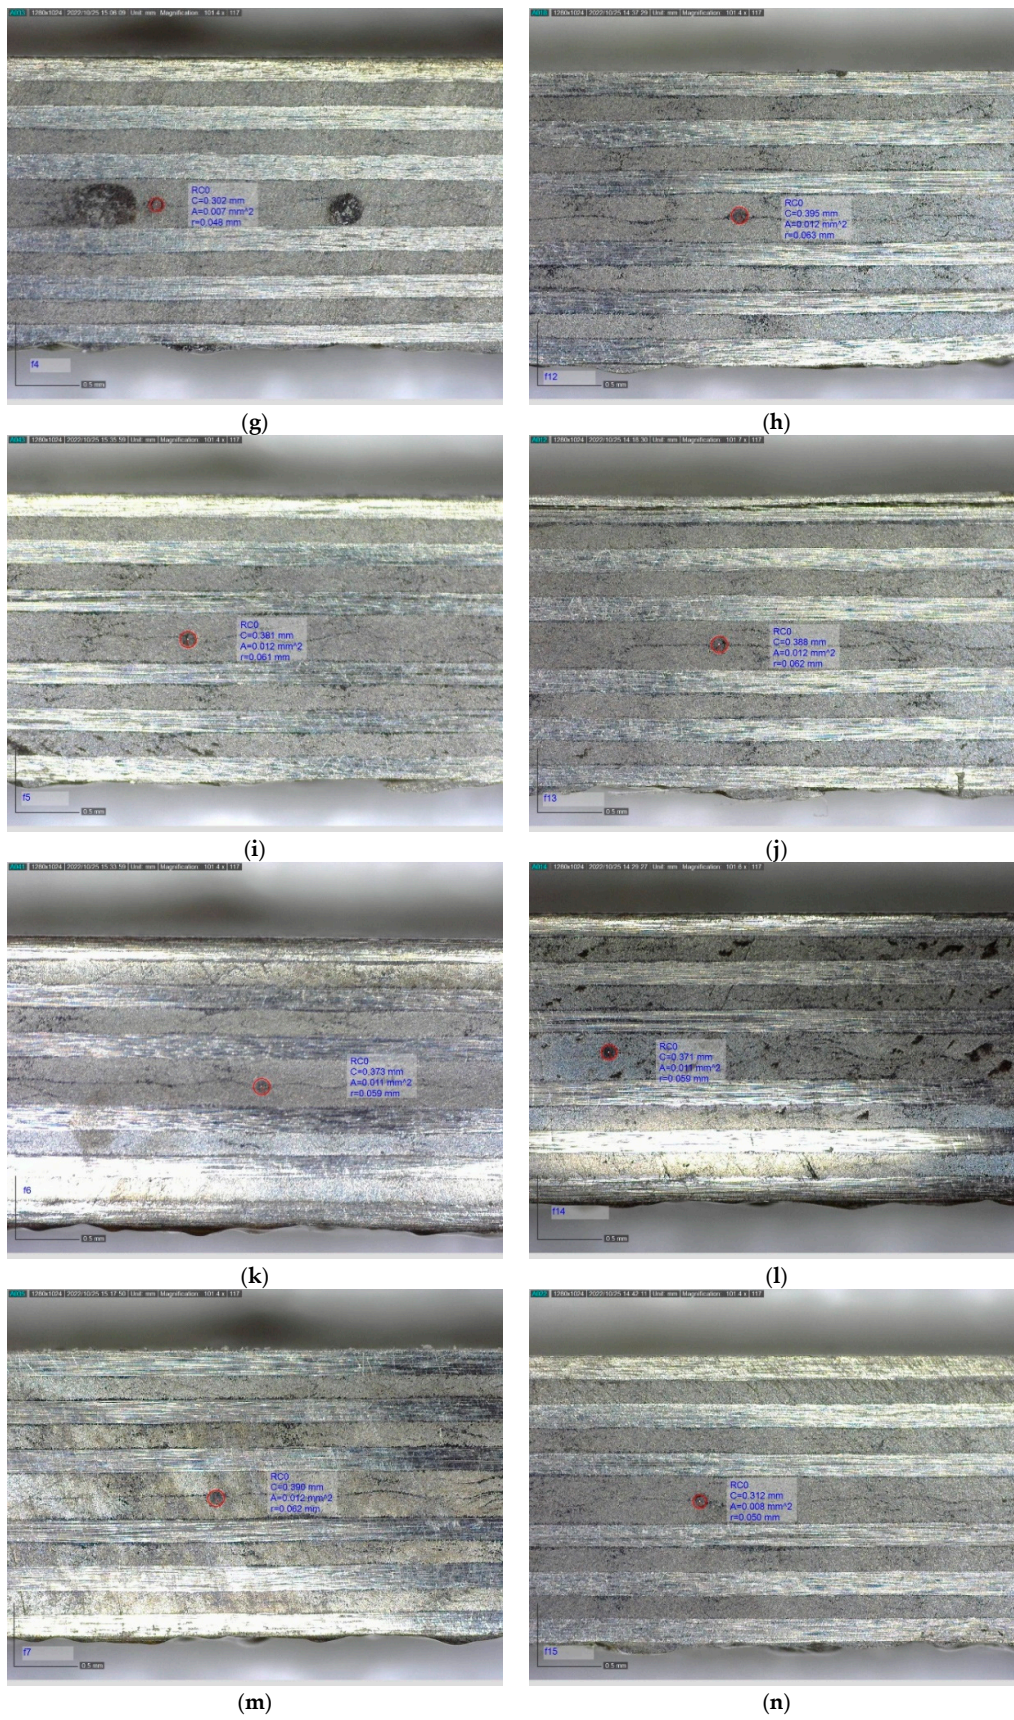
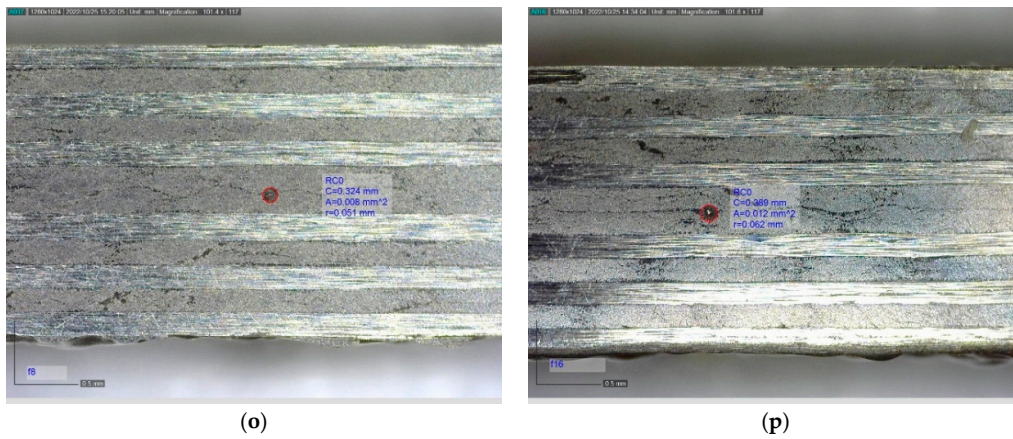
Figure A12. Cross-sections of the ILSS test coupons without embedded OF. The figures on the (left (a,c,e,g,i,k,m,o)) are from coupons after TVac conditioning. The figures on the (right (b,d,f,h,j,l,n,p)) are from coupons that were not TVac conditioned.

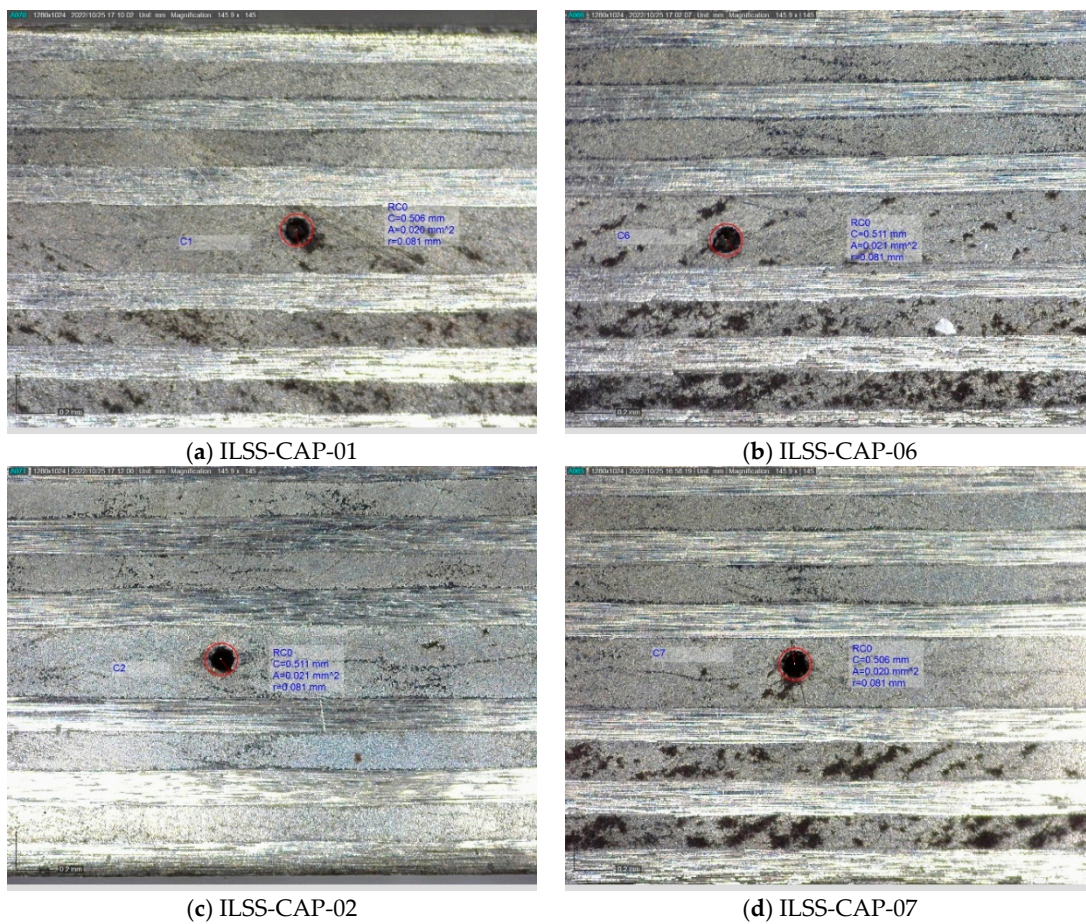
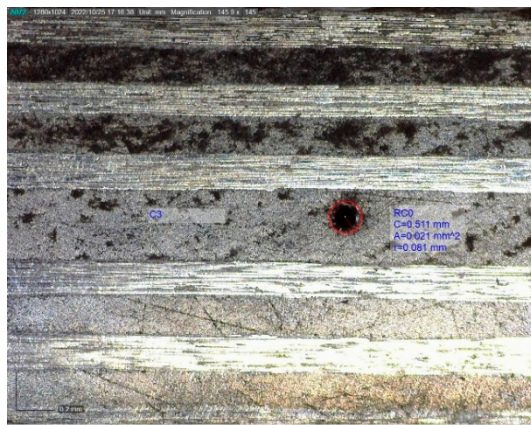
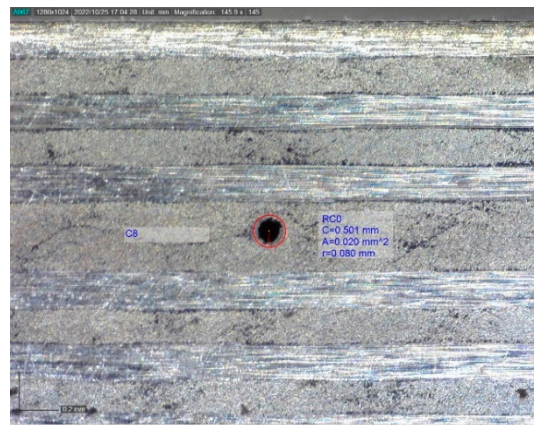
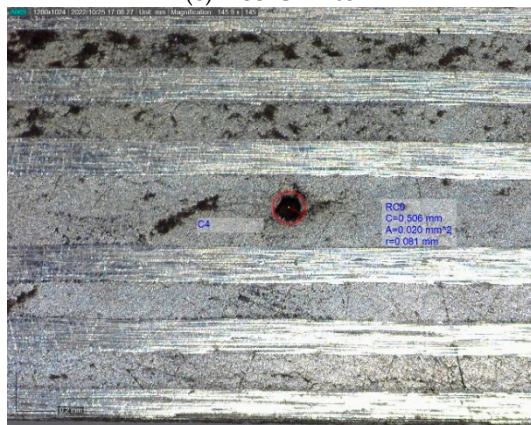
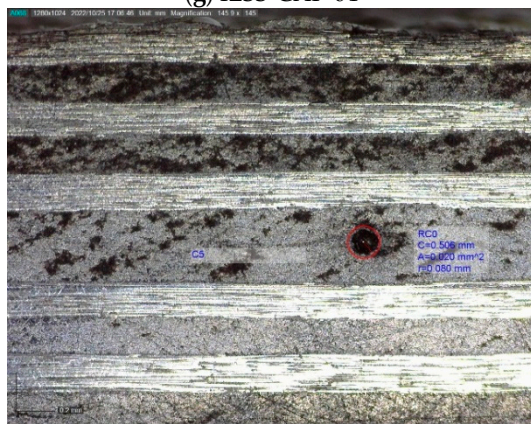
Figure A14. Cross-sections of the ILSS test coupons without embedded capillary. The figures on the (left (a,c,e,g,h)) are from coupons after TVac conditioning. The figures on the (right (b,d,f)) are from coupons that were not TVac conditioned.
