Cumulated charging mechanisms at gate processing in high- κ first planar NMOS devices

Gaspard Hiblot, Narendra Parihar, Emmanuel Dupuy, Geert Mannaert, Sylvain Baudot, Ben Kaczer, Jacopo Franco, Anne Vandooren, Vincent De Heyn, Abdelkarim Mercha
IMEC, Kapeldreef 75, 3001 Leuven, Belgium Email: gaspard.hiblot@imec.be

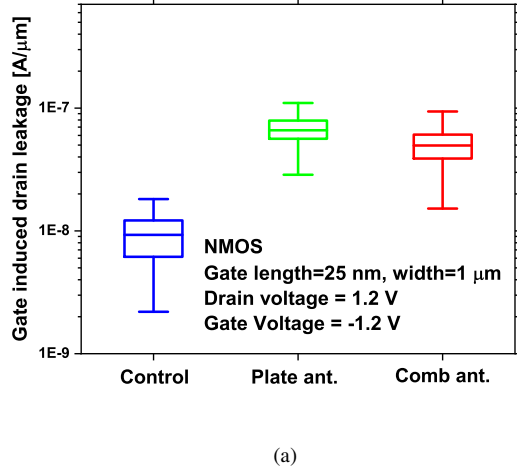
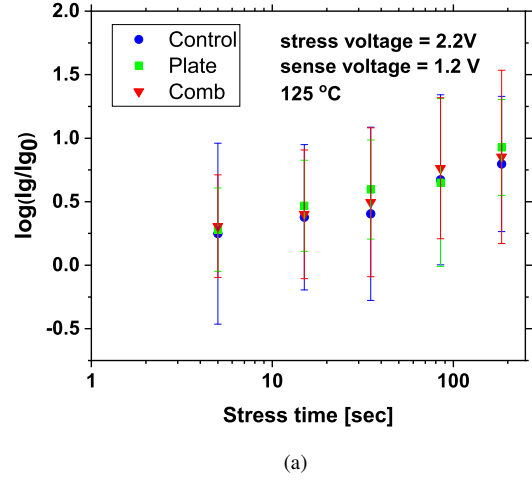
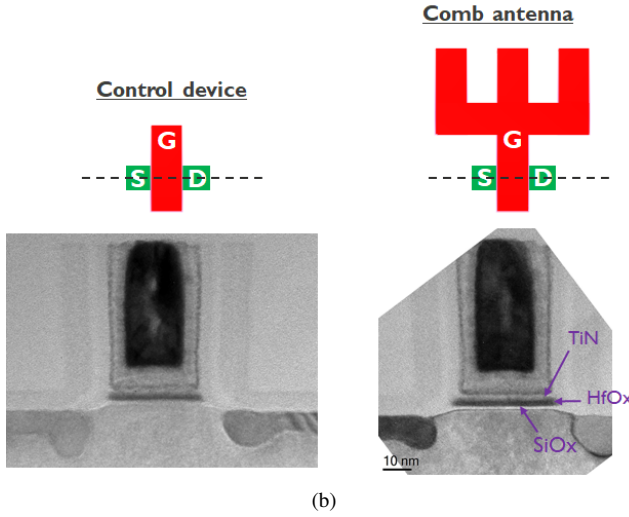
Fig. 3: (a) Gate induced drain leakage measurement. (b) TEM cross-sections of the control device and the comb antenna device.

The following time zero metrics are considered: threshold voltage (V_{th}), transconductance (g_m), gate leakage (J_G), subthreshold swing (SS) and Gate Induced Drain Leakage (GIDL). They are reported respectively in Fig. 1a, Fig. 1b, Fig. 2a, Fig. 2b and Fig. 3a. It is clear from these measurements that PID induces a selective deterioration of a limited set of parameters (in this case V_{th} , g_m and GIDL) while not the others (J_G , SS). Although the GIDL increase is particularly

preeminent, it is in the same range as in previous work [10]. To determine whether this degradation was purely electrical or linked to differences in the gate profile induced by the antenna, TEM pictures were taken on the control and the comb antenna device, which are compared in Fig. 3b. No physical difference can be observed on the two structures, hence confirming that the degradation observed are linked to electrical charges accumulated during processing and not physical impact of the plasma etch.

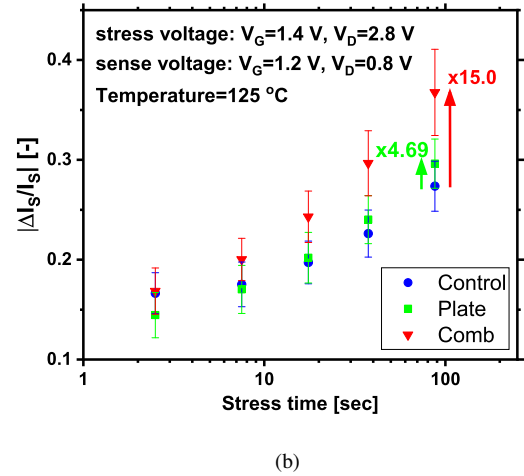
Fig. 5: (a) Stress-induced leakage current, reported as relative increase of gate current (I_g) over the initial value (I_{g0}). (b) Hot carrier injection evaluated through the relative reduction of the source current (I_s) with respect to stress time.

The following reliability tests have also been performed to detect charging damage: Positive Bias Threshold Instability (PBTI), Time Dependent Dielectric Breakdown (TDDB), Stress Induced Leakage current (SILC) and Hot Carrier Injection (HCI). They are shown respectively in Fig. 4a, Fig. 4b, Fig. 5a and Fig. 5b. Here also, the impact of PID is very selective, affecting exclusively PBTI and HCI. The results of the time-zero and reliability measurements are reported for the plate and comb antennae in Tab. II as differences from measurements on the control antenna. The symbol \emptyset means that there is no statistical difference with the control device.

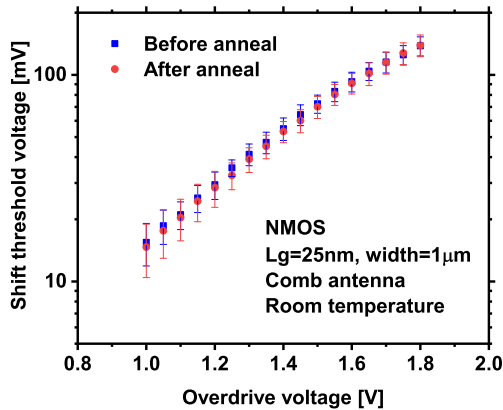
Fig. 9: PBTI before and after FGA on the comb antenna.

stronger before anneal as shown in Fig. 8a and Fig. 8b. In contrast, PBTI is not affected by the FGA, as can be observed from the comb antenna results in Fig. 9.
